## Project Info

Lowestoft, Suffolk, UK

CC installed onto steel pile beach groyne to block voids, prevent accident and reduce beach loss.

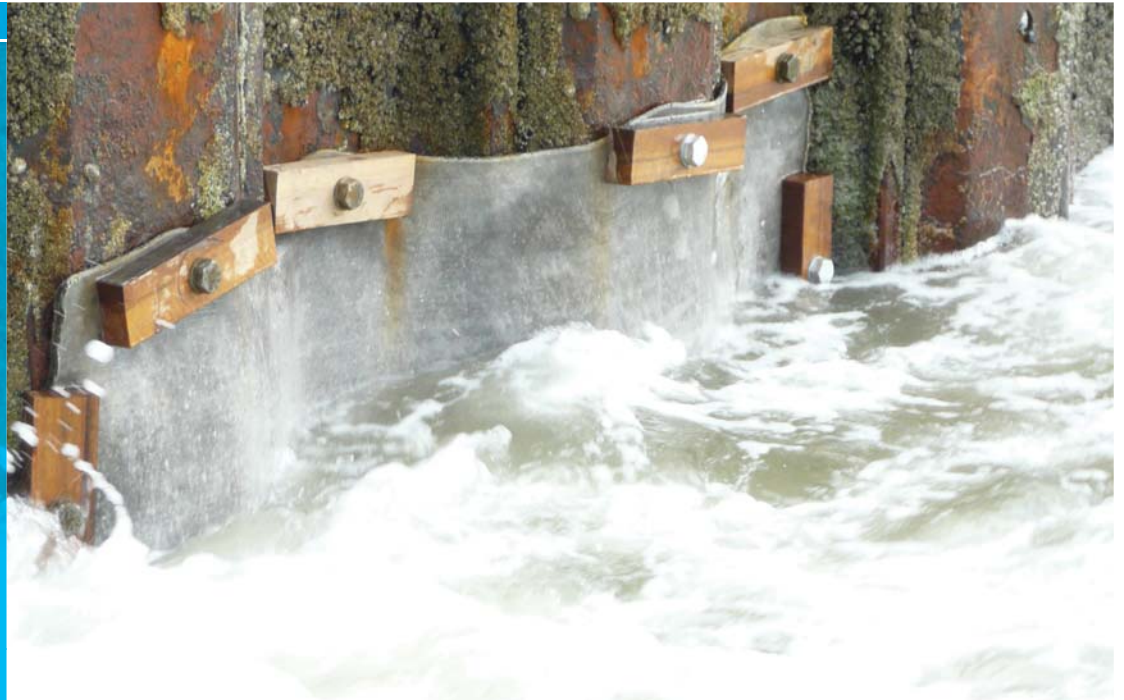
Completed repaired groyne section at high tide

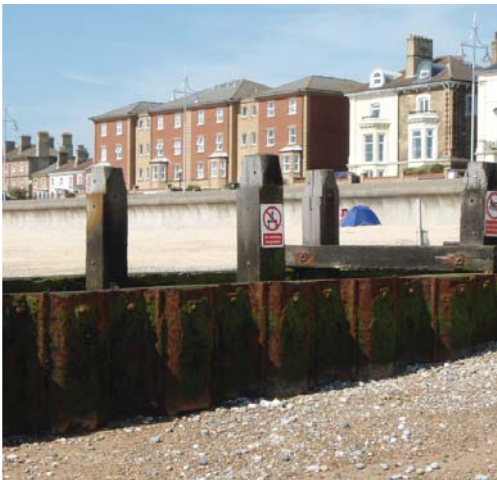
Steel pile beach groyne, Lowestoft

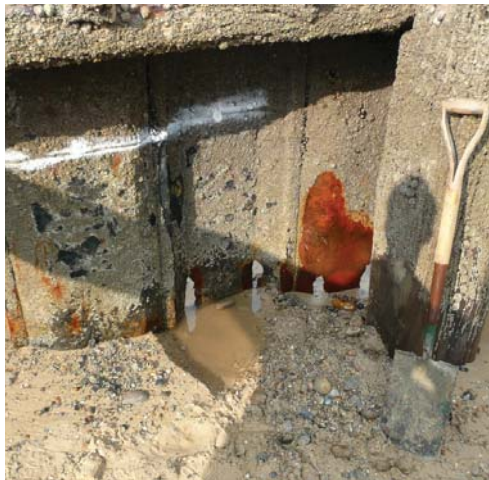
Groyne section in disrepair with dangerous voids
