CC8 Bulk Rolls

Cunningham's Gap,
Queensland, Australia

CC8 used to remediate eroded concrete channels collecting and discharging water run-off from hillside adjacent to highway.

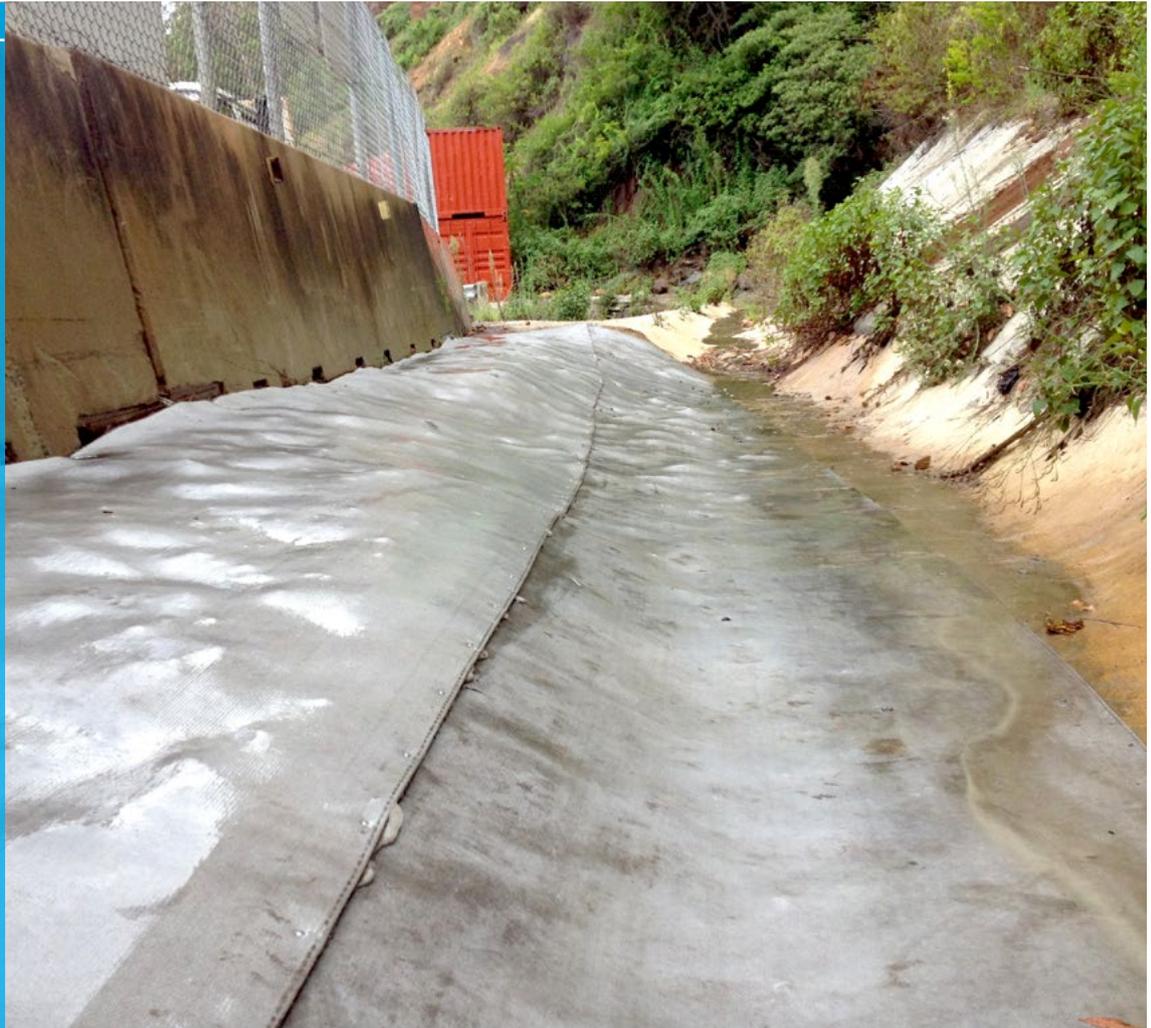
Section of ditch immediately following hydration

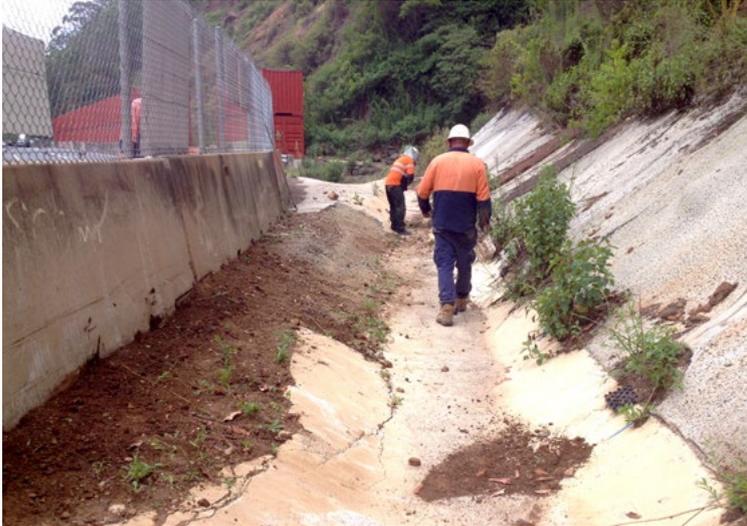
The site was cleared of vegetation and debris before installation

Prior to installation the site was cleared of vegetation and debris, and several cuts were made into the existing channel to allow CC to be fixed with grout at the top end of the water flow. Bulk rolls of CC8 were then delivered to site and unrolled into the channel using a crane truck and spreader beam. The CC was cut to length and fixed in place using ground anchors and concrete screws. Adjacent layers of CC were fixed together using stainless steel screws and Sika Pro adhesive. The interface between CC and the cuts in the channel made during preparation were filled with a non-ferrous, non-shrink grout, which ensured no undermining of the CC during heavy water surges. CC was then hydrated using a water truck and spraying equipment.

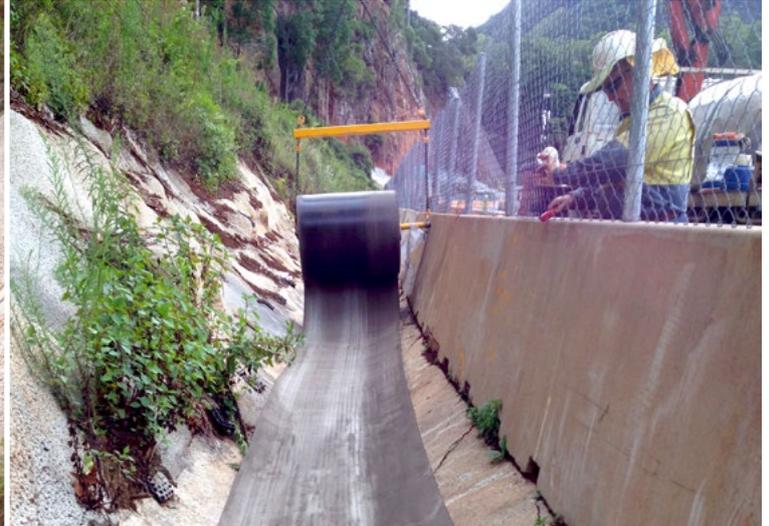
Bulk rolls of CC8 were dispensed using a spreader beam and crane truck

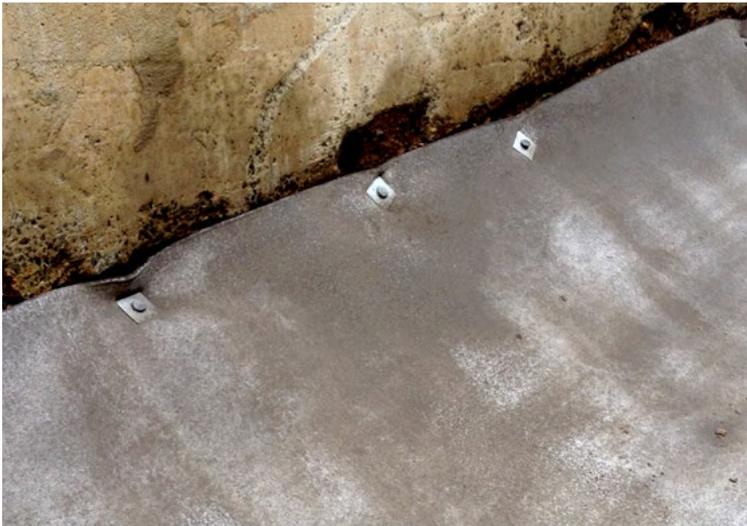
CC was fixed to the channel base using concrete anchors and screws

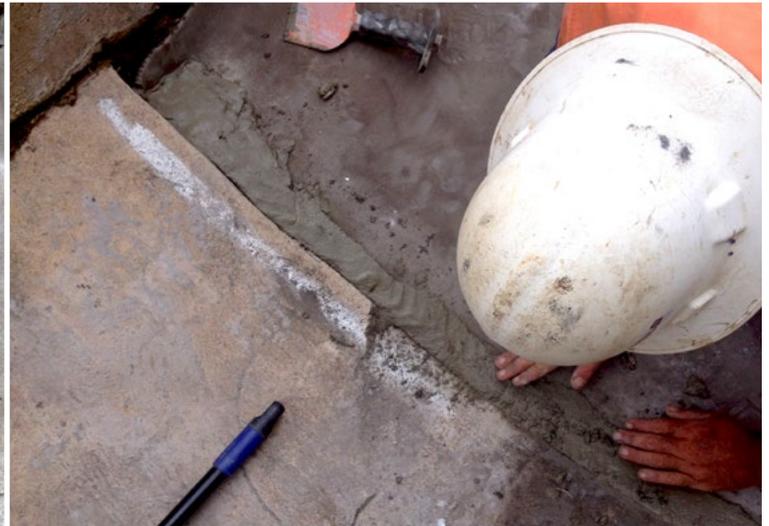
Grout was used at the end of the relined channel to prevent water ingress

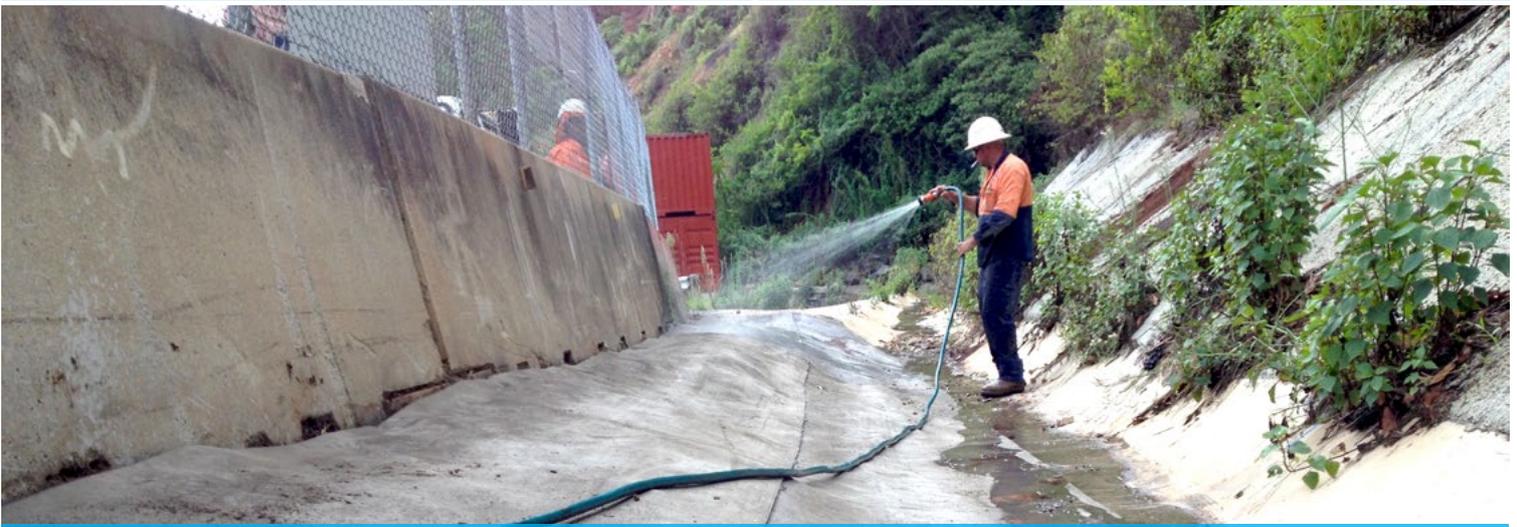
CC was hydrated using a water truck, pump and hose
