CC5 Bulk Rolls

Cunningham's Gap,
Queensland, Australia

CC5 used to provide an erosion-control solution to a slope adjacent to the Cunningham Highway in Queensland, Australia

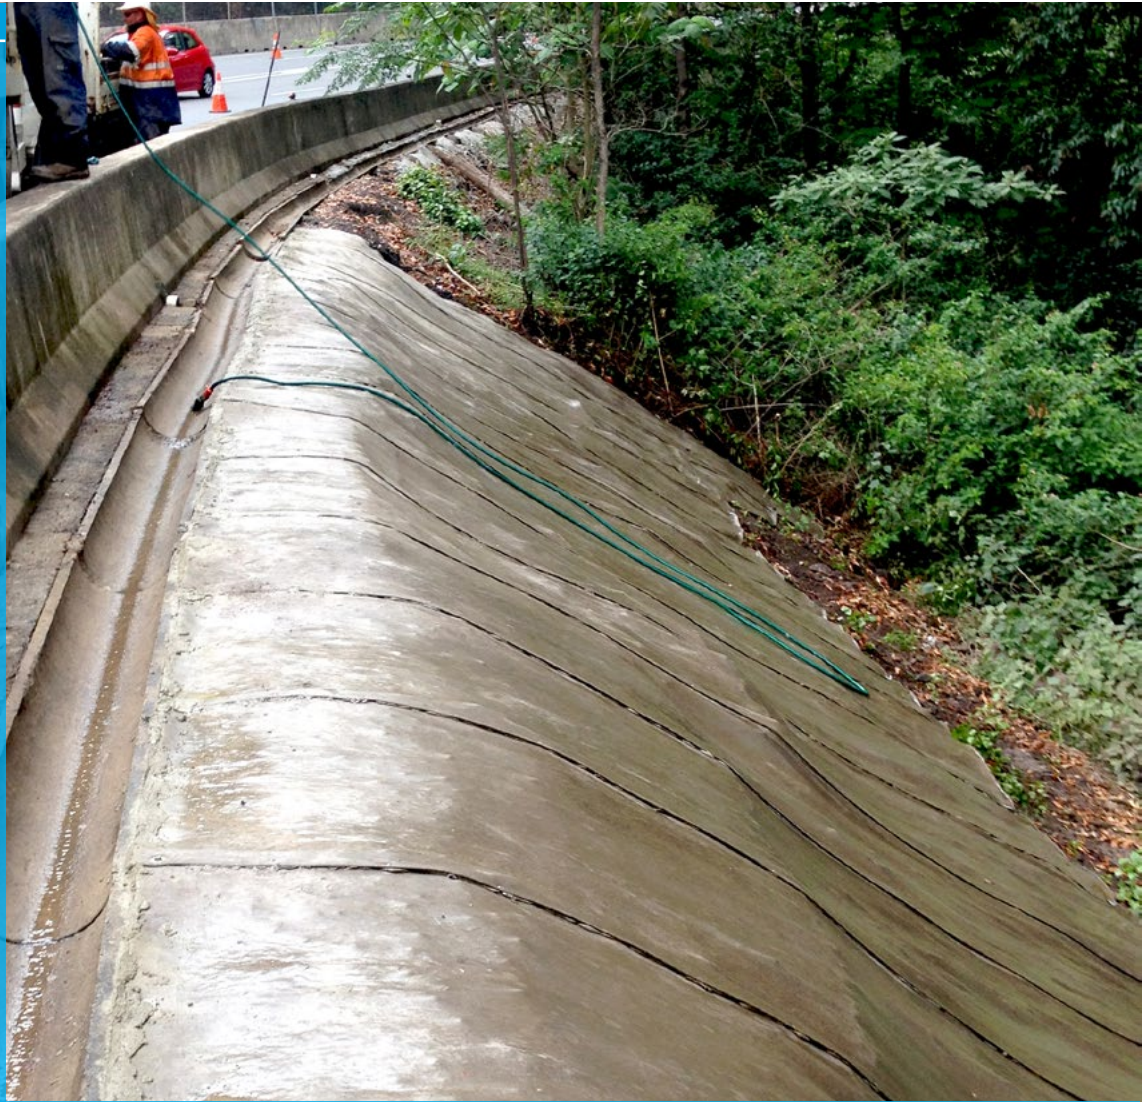
Section of slope immediately following hydration

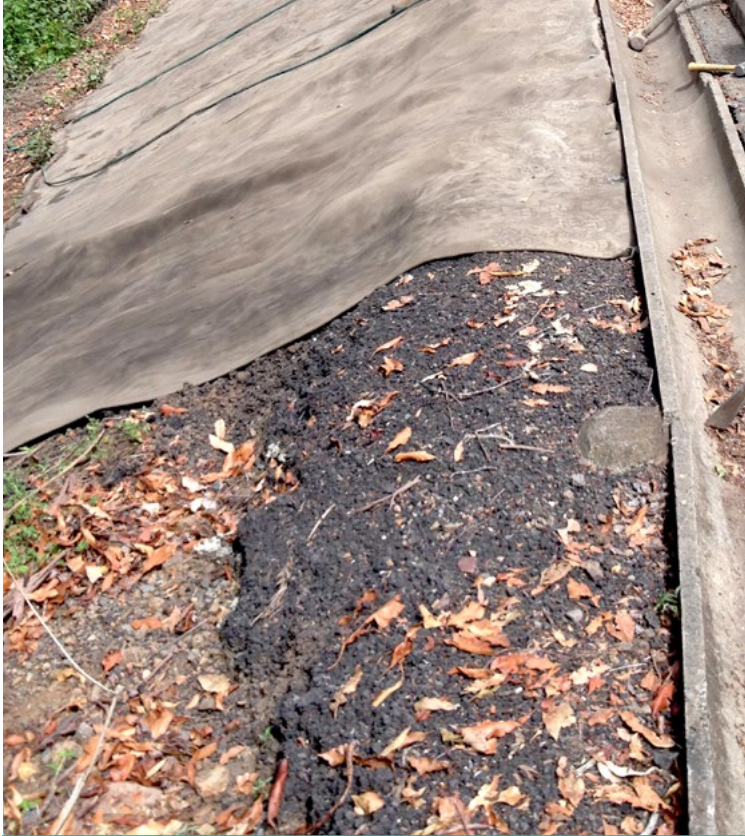
In January 2014, Concrete Canvas (CC) was used to remediate a section of slope adjacent to Cunningham Highway in Aratula, Queensland. The slope had suffered erosion caused by insufficient drainage. A solution was needed to protect the slope from further damage, as threatened to destabilise the adjacent road. Shotcrete had been considered to line the slope, but roadside barriers created issues with site access. The equipment and rebound associated with shotcrete could also cause delays and damage to the vehicular traffic using the road.

The existing slope liner had suffered erosion and damage

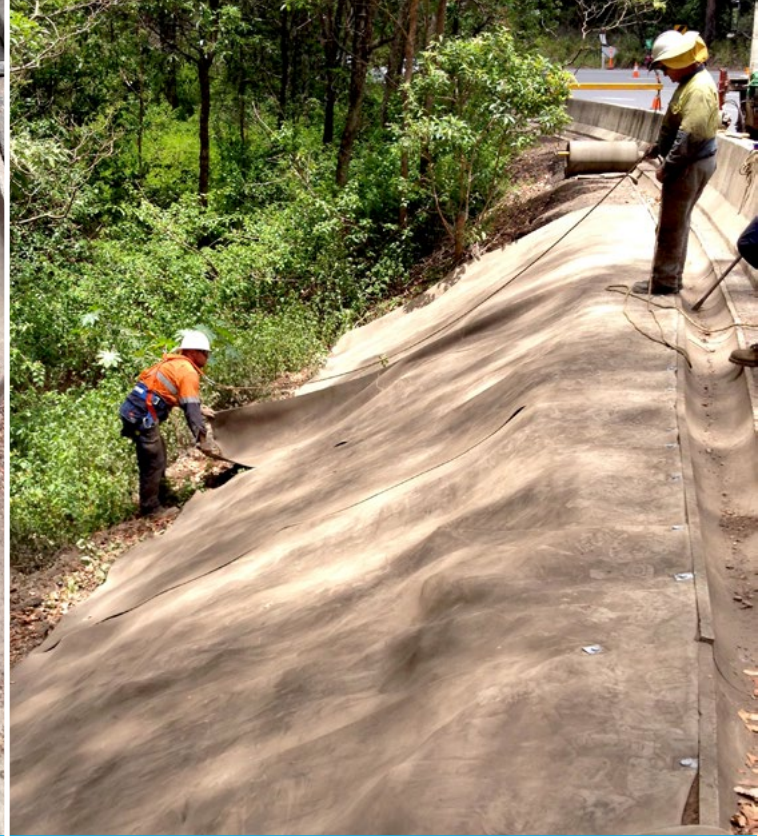
Bulk rolls of CC5 were dispensed using a spreader beam and crane truck

Prior to installation the site was cleared of vegetation, before bulk rolls of CC5 were delivered to site, deployed using a crane truck and spreader beam and cut to length. Each length of CC was then fixed to the substrate using ground anchors and concrete screws and fixed to adjacent lengths using stainless steel screws and Sika Pro adhesive. The interface between CC and an existing spoon drain at the head of the slope was sealed with a non-ferrous, non-shrink grout, with the CC pinned in place. A water truck and hose equipment was then used to hydrate the CC after the grout had set.

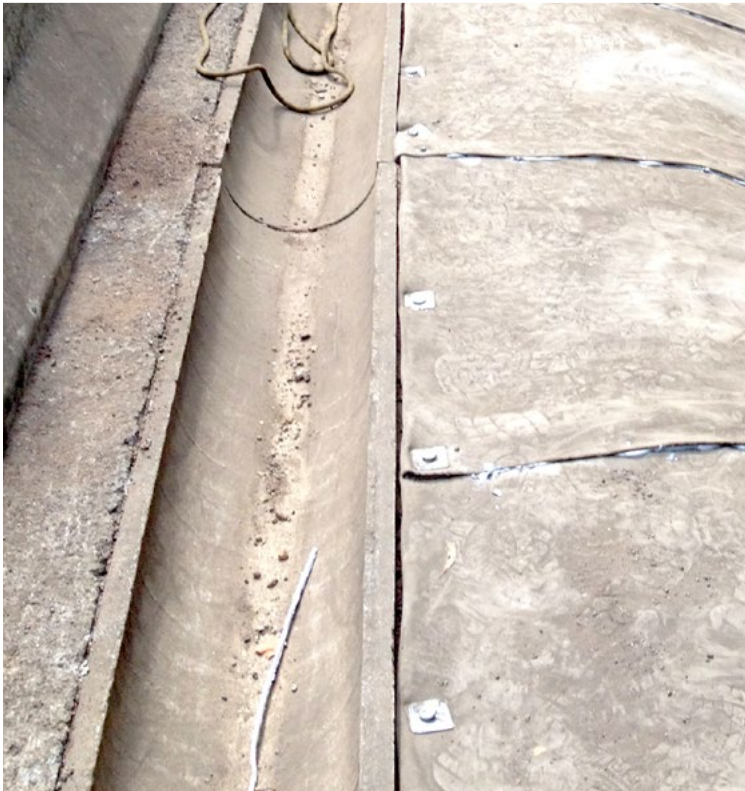
CC was fixed to the slope substrate using concrete anchors

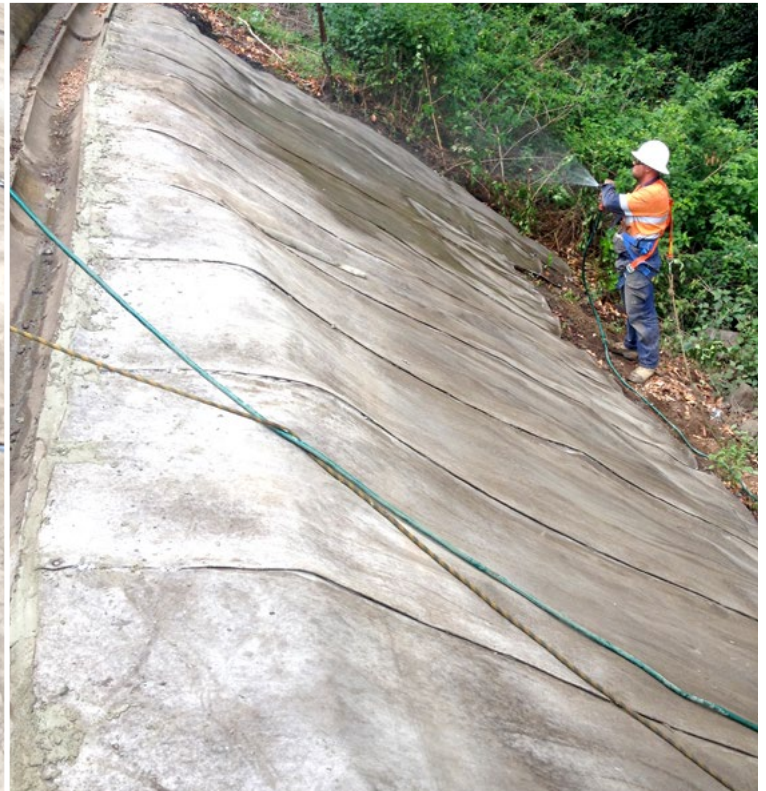
Grout was applied to the head of the slope prior to hydration
