Monegros Channel,  
Huesca, Spain

CC5 was used to repair and waterproof a section of concrete channel, which was suffering from severe erosion and cracking.

## 30.11.11 Case Study : Monegros Channel

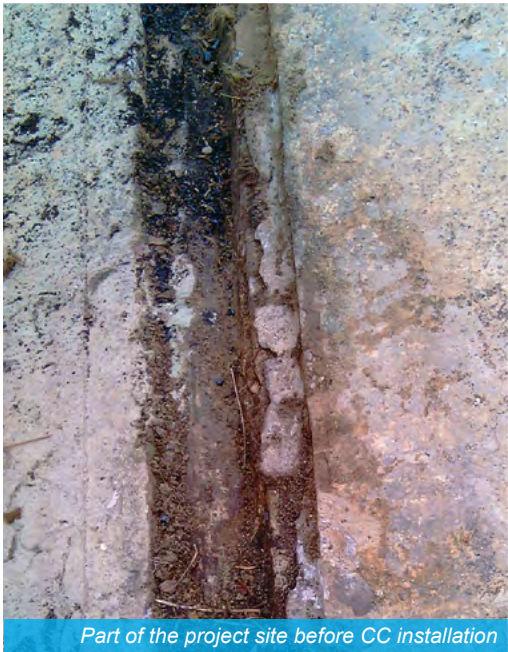
Part of the project site before CC installation
