CC8™ Bulk Roll

Canaa Dos Carajas,
Para, Brazil

CC8™ used to line a ditch
on a steep embankment

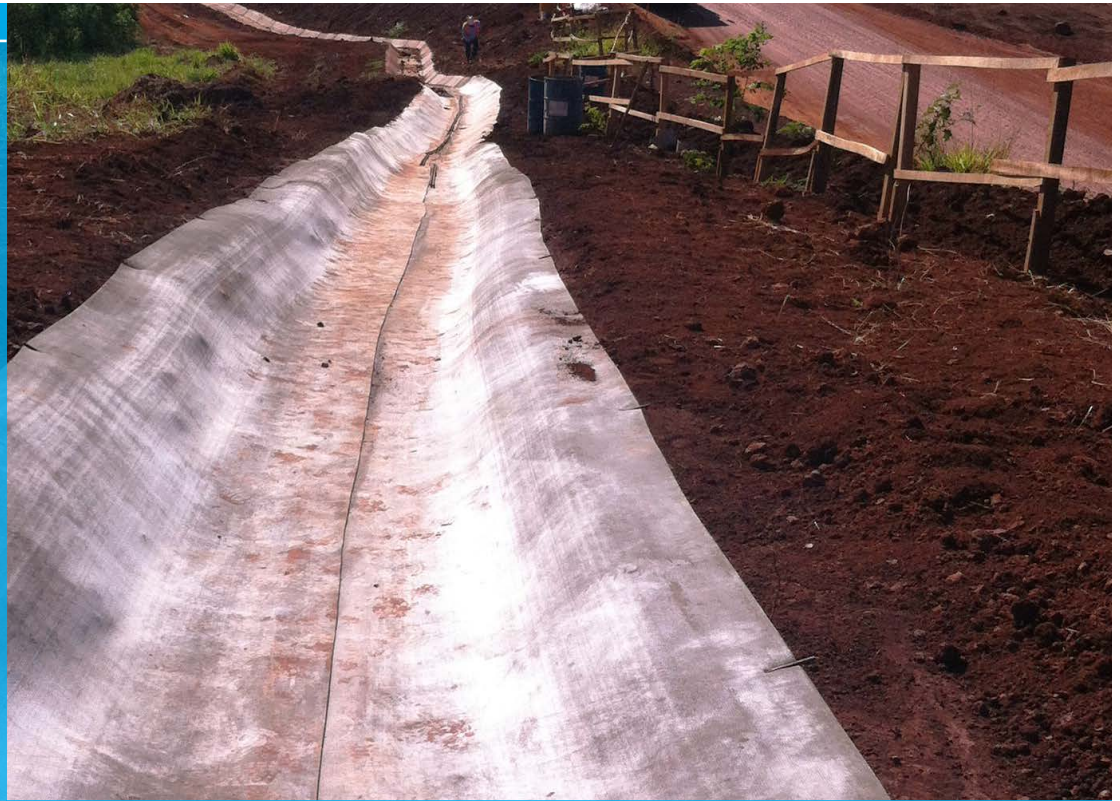
Completed ditch

In July 2014, Concrete Canvas GCCM* (CC) was used to line a 56m long section of ditch located on a steep embankment next to a road in Canaa Dos Carajas, Para, Brazil. Rainwater was infiltrating and eroding the embankment, risking slip. The installation was conducted as a trial with CC being installed alongside poured concrete.

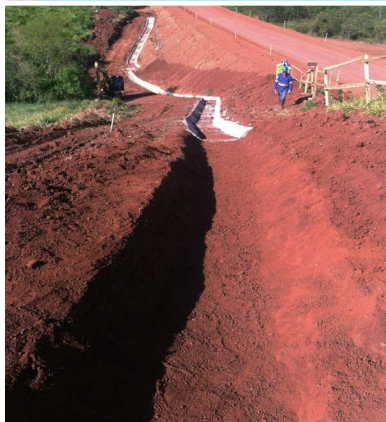
Site before works began

Installation was carried out by Consortio S 11 D, and the CC was purchased by Construtora Barbosa Mello for Vale S 11 D. Prior to the installation of 8mm thick CC (CC8™) the ditch was excavated to profile and cleared of any loose rubble. A bulk roll of CC8™ was delivered to site and suspended from an excavator with a spreader beam. This was unrolled longitudinally into the ditch in 2 layers, with a 100mm overlap between them. The CC8™ was fixed to the substrate with ground pegs every 2m, and screwed along the overlap every 200mm.

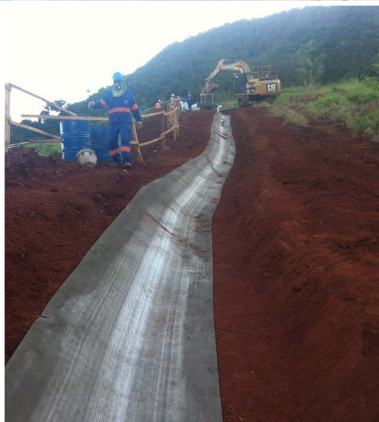
One layer of CC unrolled

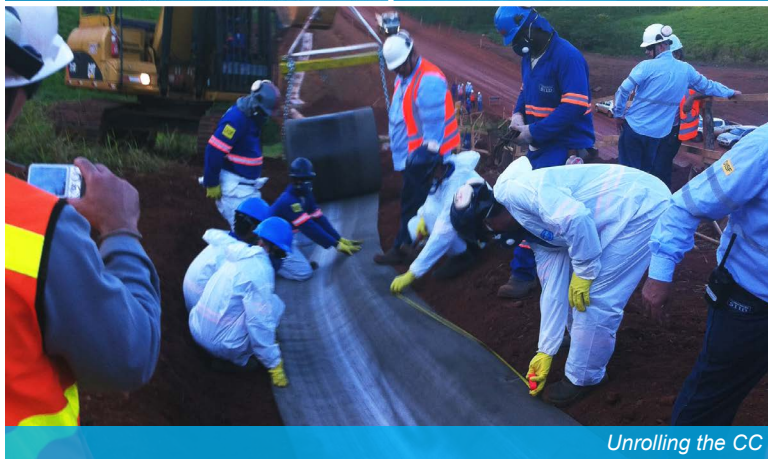
Unrolling the CC
